NASA WG3 MMOD Protection Summary

33rd Interagency Space Debris Coordination Committee (IADC)
March-April 2015

Summary of MMOD Protection Activities

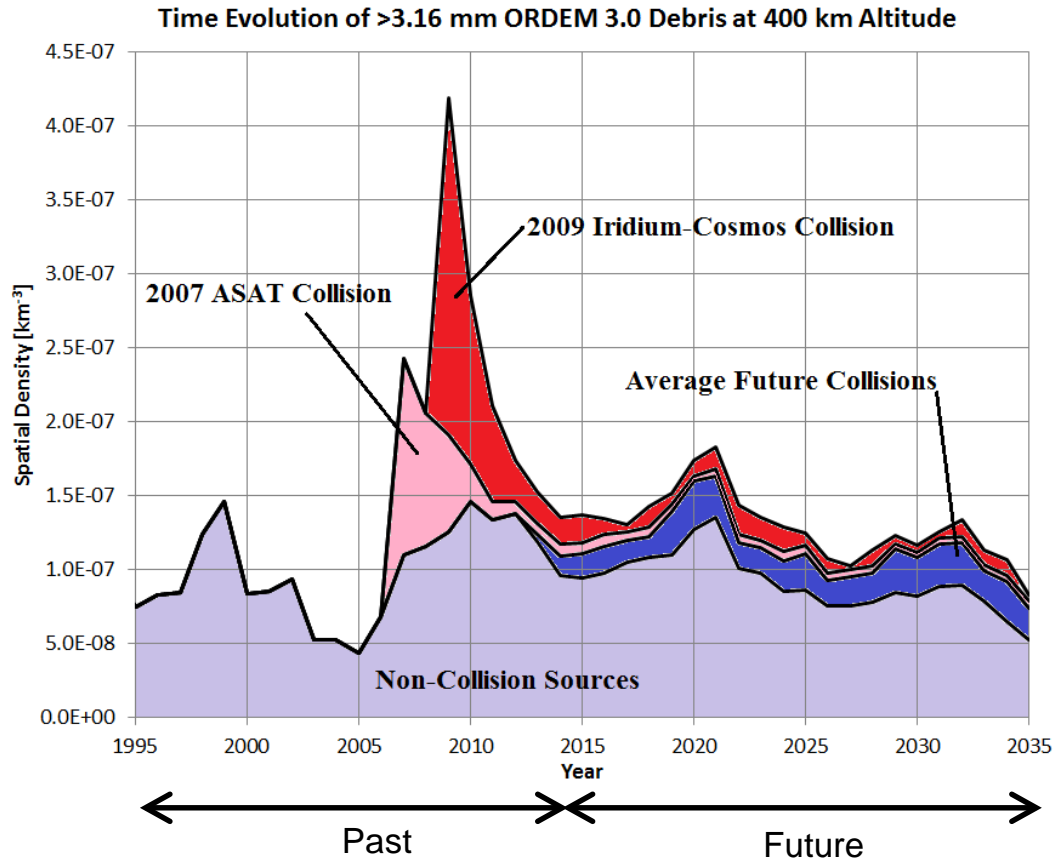
Past Environment vs. Future Risk; > 3 mm

- Predicted spatial density in the future is somewhat higher than pre-2007 measured values even though the contribution from the two collisions has dropped to very low levels.
- Part of the increase is due to averaging 120 different future “realities.”
 - Each future Monte Carlo environment has 0, 1, 2, or more future collisions or explosions at “random” times.
- The future level is an accurate representation of the risk to ISS.

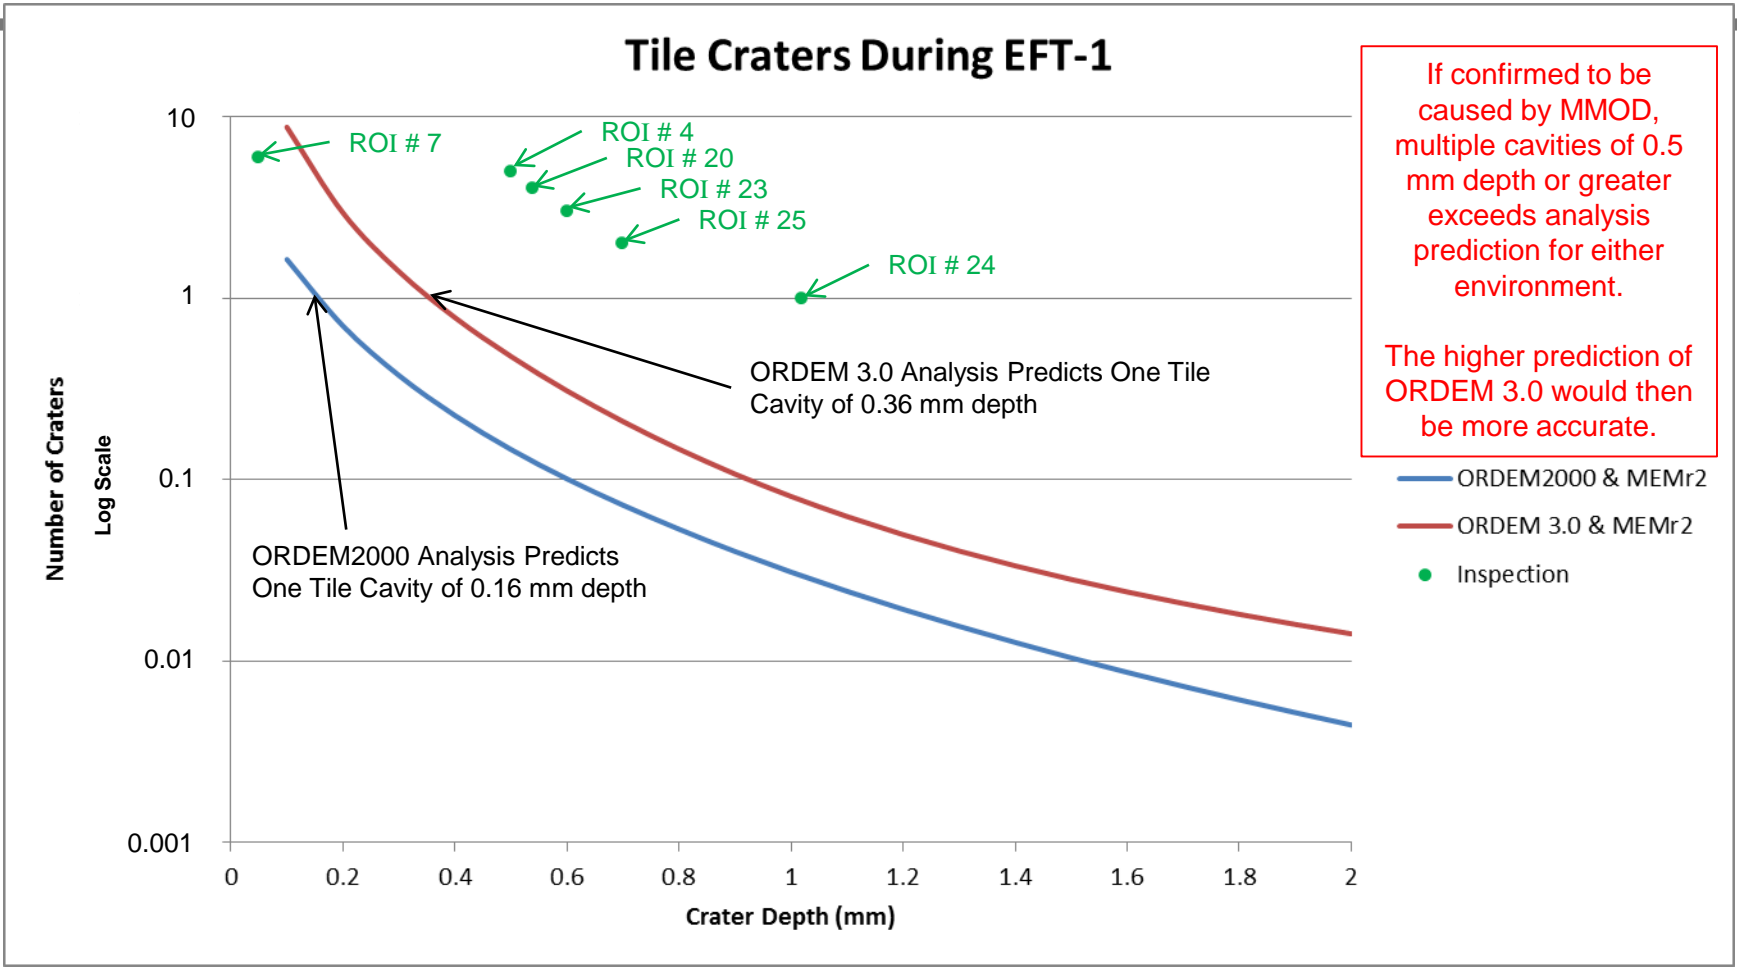
Backshell Tile Damage Predictions compared to Observations

Using ORDEM2000

Smallest damage sizes are ~70% OD / ~30% MM
Medium damage sizes are ~85% OD / ~15% MM
Largest damage sizes are ~90% OD / ~10% MM

Using ORDEM 3.0

All damage sizes are ~95% OD / ~5% MM

ROI # 7	ROI # 4	ROI # 20	ROI # 23	ROI # 25	ROI # 24
0.05 mm	0.50 mm	0.54 mm	0.60 mm	0.70 mm	1.02 mm
	OD3: 38%	OD3: 34%	OD3: 27%	OD3: 19%	OD3: 7%
	OD2k: 14%	OD2k: 12%	OD2k: 10%	OD2k: 7%	OD2k: 3%
